PUBLIC SAFETY FACILITY ASSESSMENT

TOWN OF WESTMINSTER, MA

MARCH 2019

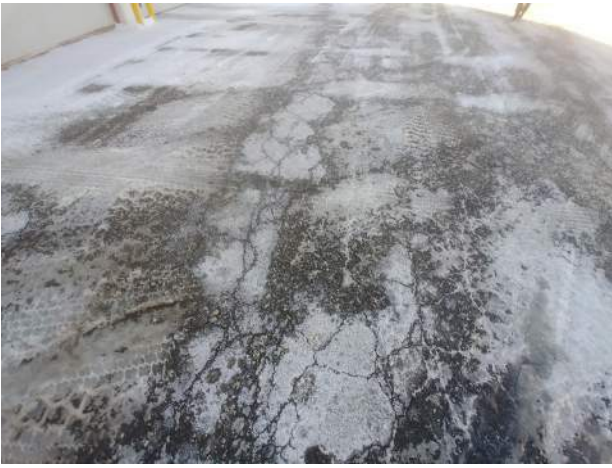
001

Bituminous pavement and concrete aprons for the apparatus bays are deteriorating, and will likely need replacement in the next 5 years (001). Parking is also not adequate to serve this facility. Currently, visitor parking is limited to a couple of spaces adjacent to the visitor entrance, if those are occupied then visitors will need to park closer to Town Hall, forcing them to walk across the Fire Department apron. This is not a preferred arrangement and is a potential hazard (004).

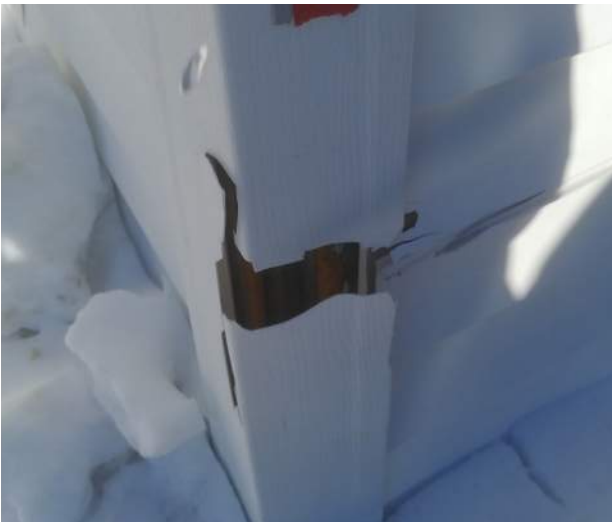
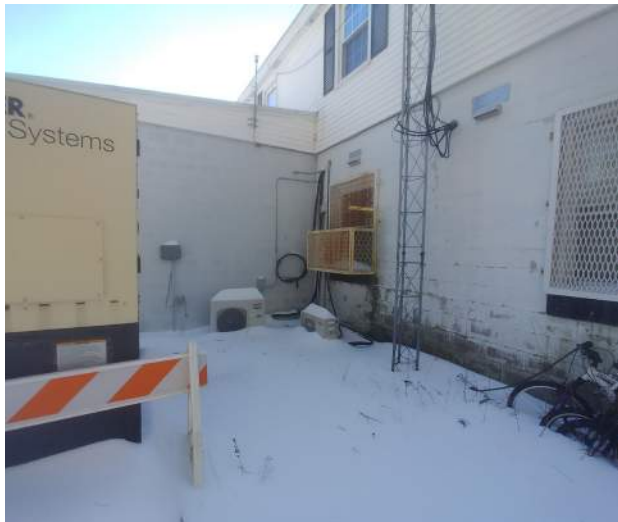
005

Roof edge trims, such as fascias and frieze boards are aluminum wrapped wood. Other trims and soffits are vinyl. Most of this material is in fair condition, with only specific areas requiring repair from either impact damages or mold and mildew propagation (005 / 006).

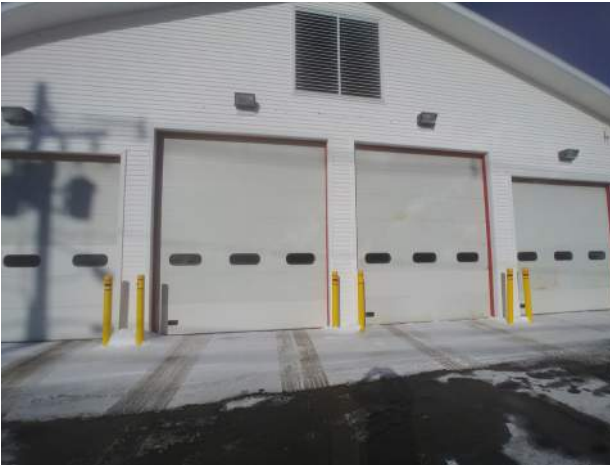
007

Siding is generally in poor condition. Specific areas require repair from impact damages (008 / 009). Other locations, specifically on the North side of the building where sun exposure is limited, mold and mildew has propagated and needs to be cleaned (010 / 011).

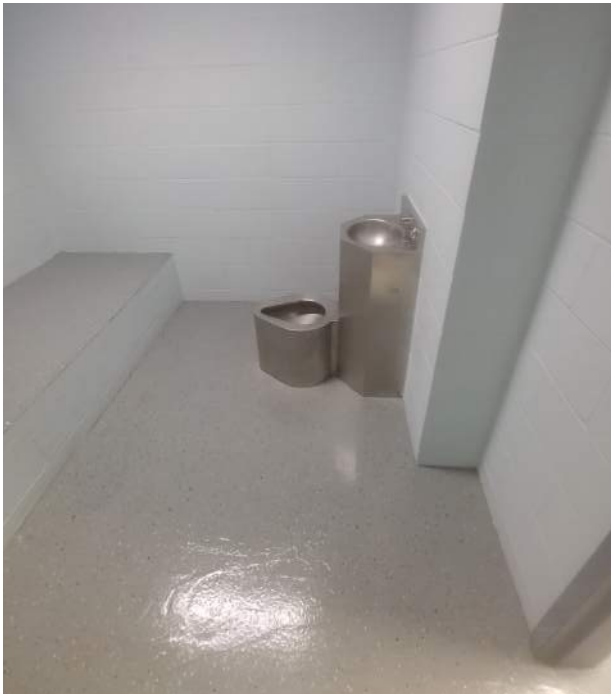
014

There is currently only a single cell. The cell is directly off of the booking room and does not have compliant sight sound separation. Also, the penal toilet sink combo is not an ADA compliant fixture. The diffusers for the HVAC system to the cell appears to be MaDPH 105 CMR (Massachusetts Department of Public Health Regulations) compliant. The requirement is that the perforations are no larger than 1/8". The ceilings are low, approximately 8'-6". It is recommended that ceilings in the cells are kept to a minimum of 10'-0". We were not able to determine if the existing HVAC system comply with MaDPH requirements for air hourly air changes while a person is detained (014 / 015).

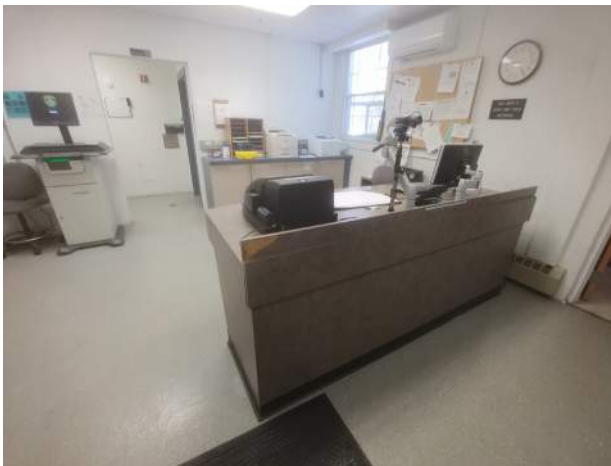
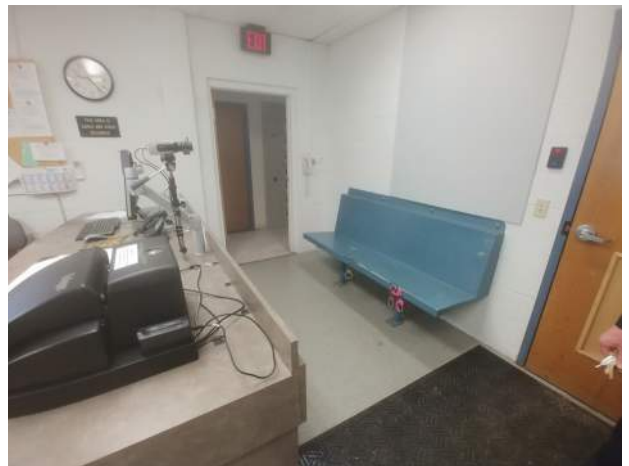
016

The booking area is functional and adequately sized. The biggest concern in this space is the millwork. All of the counters and cabinets are plastic laminate over particle board. The adhesive has begun to break down over time and is causing the finish to de-laminate. This material is very rigid and sharp, and should a detainee get a hold of a piece of this material, it can be used as a weapon to either harm oneself or the attending officer (016 / 017).

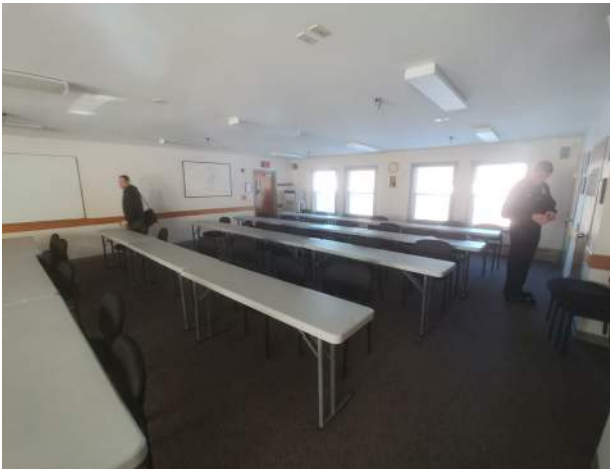
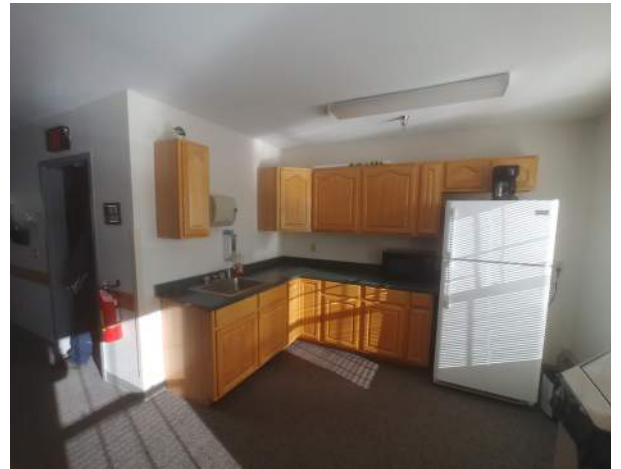
020

The existing training room is in good condition. Technology upgrades would be necessary. The ceiling height for the size of the room is too low for adequate displays. If this space was to be renovated for use as a modern training room and Emergency Operations Center (EOC), additional monitors should be placed around the perimeter and power and data floor boxes should be installed under the tables (020 / 021).

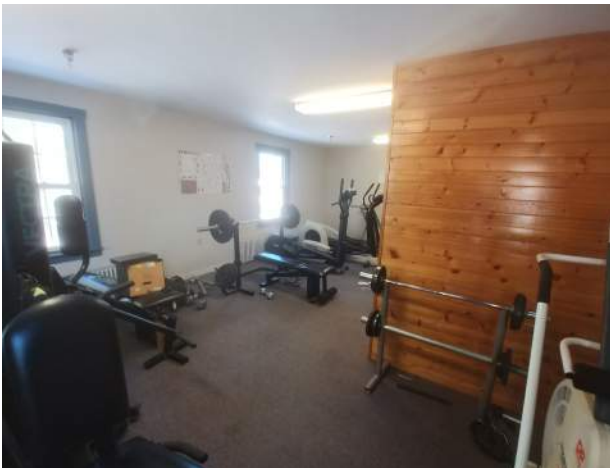
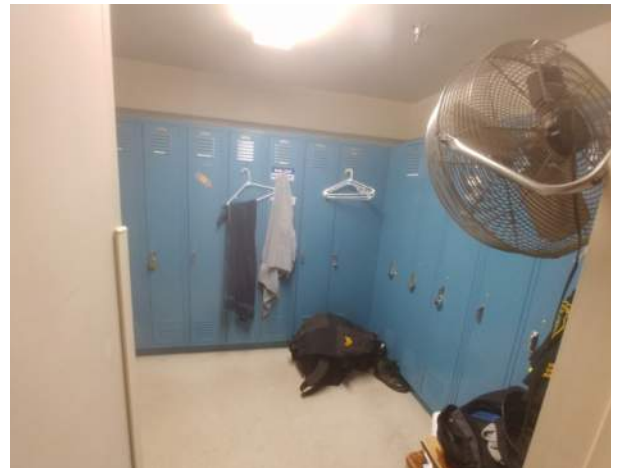
022

Fitness Room is small for the size of the department. Flooring is broadloom carpet, which is not appropriate for sanitation or reducing sound transfer to the floor below. Locker facilities are small and do not provide adequate personnel storage(22 / 23).

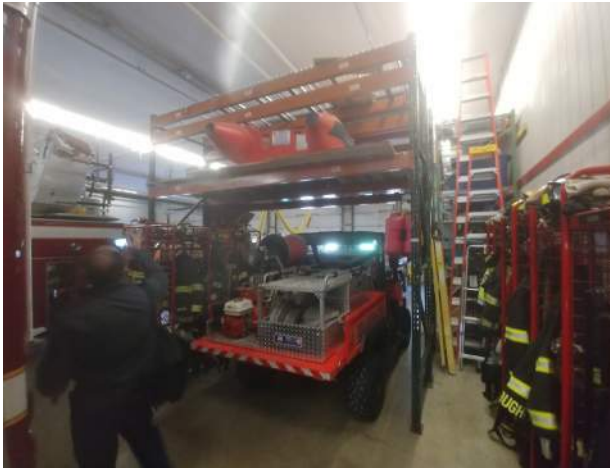
026

Storage for the department is an issue. Currently, items that should be stored in separate rooms are stored in racks within the bays (026). In addition to storage, the adjacencies to the bays is a health issue. Break and kitchen areas, the day room and bunks are all directly off of the apparatus bay without a transition zone. Best practices require a transition zone where hazardous particles can be removed from clothing when going from the 'hot zone' to the 'cold zone'. There should also be positive pressure from cold to hot as well to prevent the spread of containments. This is a necessity in new fire station design to reduce the exposure to toxic chemicals and debris.

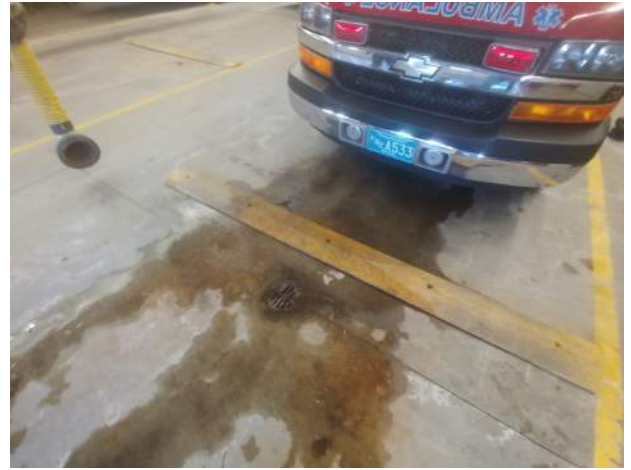
027

The apparatus bays are in fair condition. The slab is called out as 6" concrete per the 1995 addition drawings with no radiant flooring. For modern loads imposed on these slabs it is preferred that an 8" slab with radiant flooring be provided (024). The transitions between the slab and the apron are deteriorating, causing cold air and water to infiltrate under the overhead doors (025). Floor drainage is undersized. Typically 24'-0" long trench drains should be installed on center between each bay rather than single 4" round drains (027).

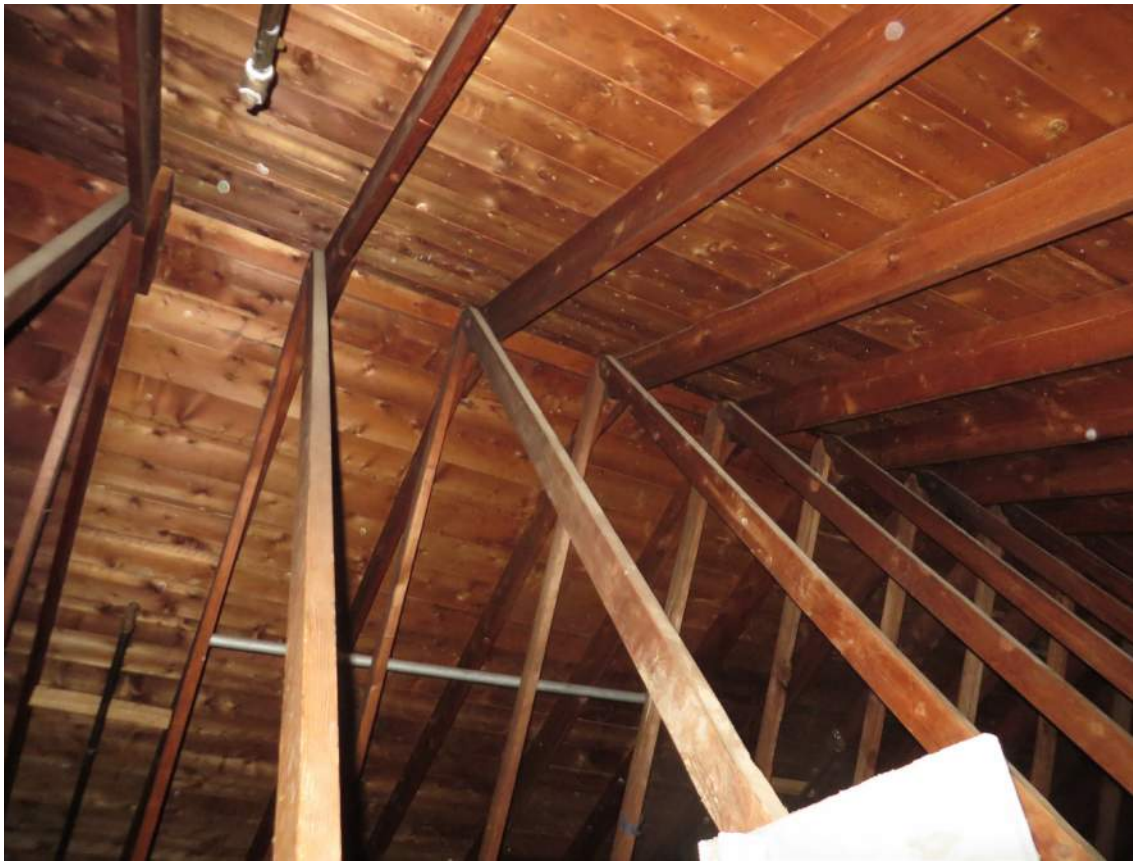
A set of the original architectural drawings from the 1995 Fire Department addition were provided to your office during the site visit. The drawings were prepared by Haynes Lieneck and Smith Inc. and dated February 23, 1995. The drawings indicate that the roof structure for the addition is comprised of plywood sheathing supported by wood trusses that are spaced at 2'-0" o.c. The second floor structure is comprised of plywood

1 - Roof Structure - Police Department

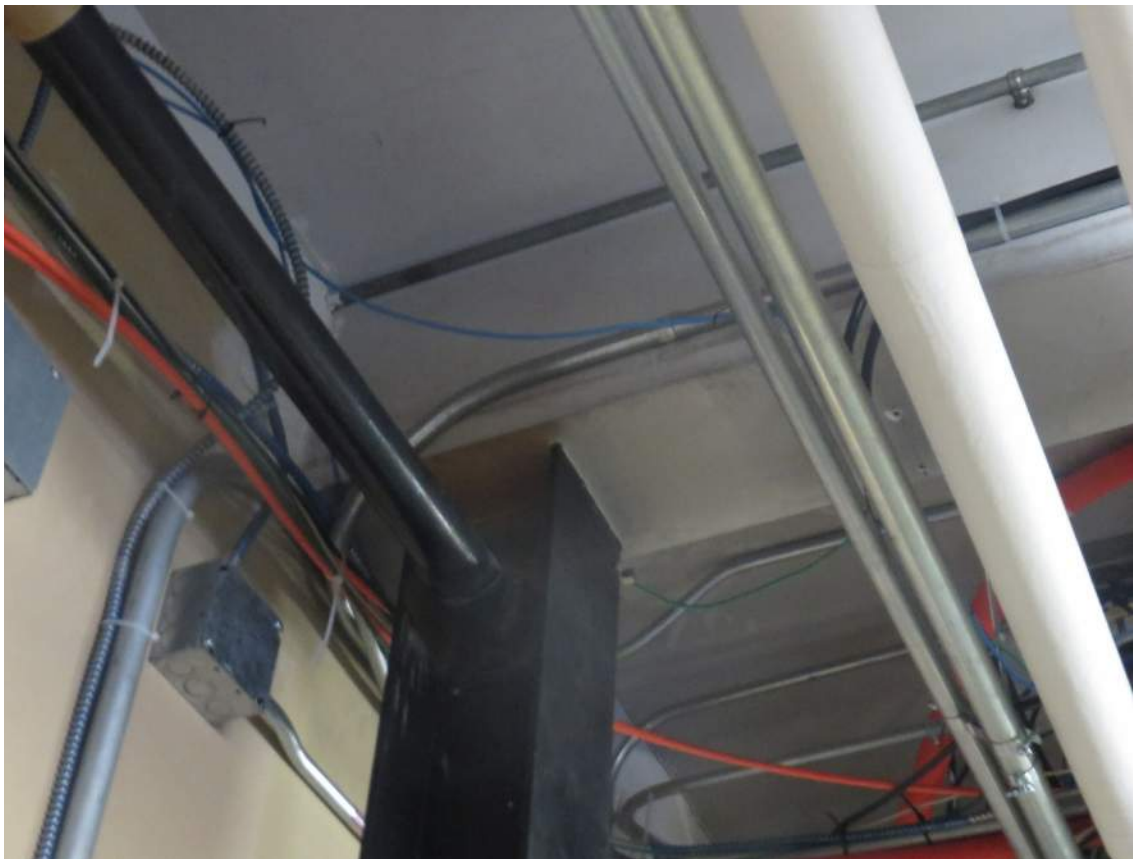
2 - Second Floor Structure - Police Department

sheathing supported by wood trusses that are spaced at 2'-0" o.c. The roof framing and second floor framing are supported by 2x6 wood stud bearing walls along exterior and interior bearing lines. It is assumed that the existing exterior and interior wood stud walls that align floor to floor act as shear walls, and therefore comprised the lateral system of the building.

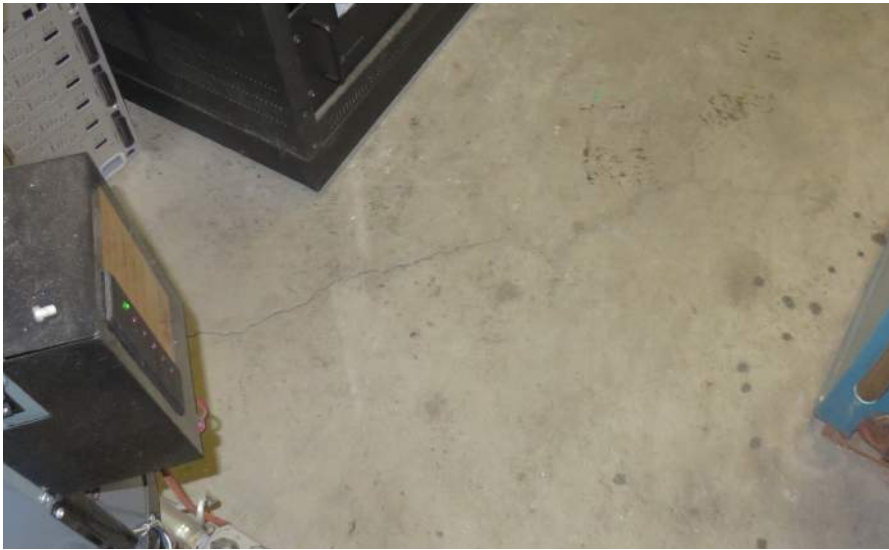
4 - Concrete slab-on-grade hairline cracks - Police Department

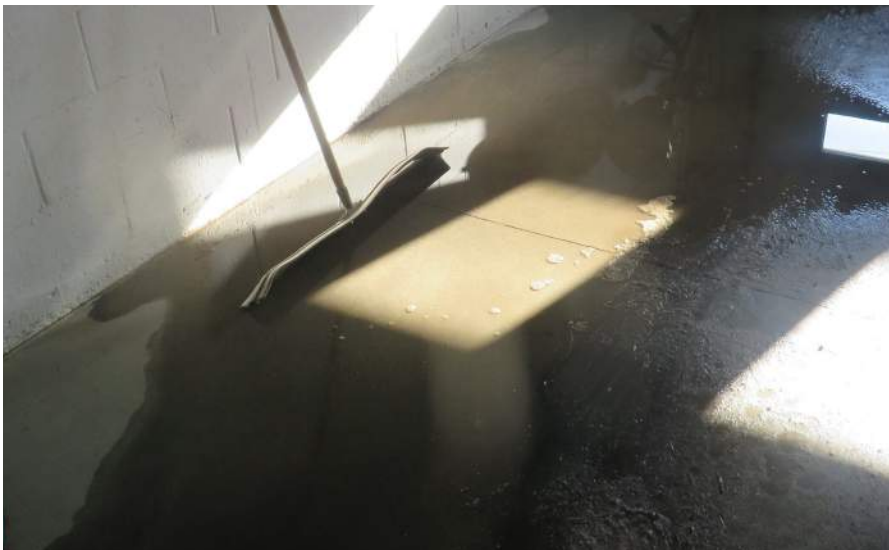
5 - Standing water in Sally Port - Police Department

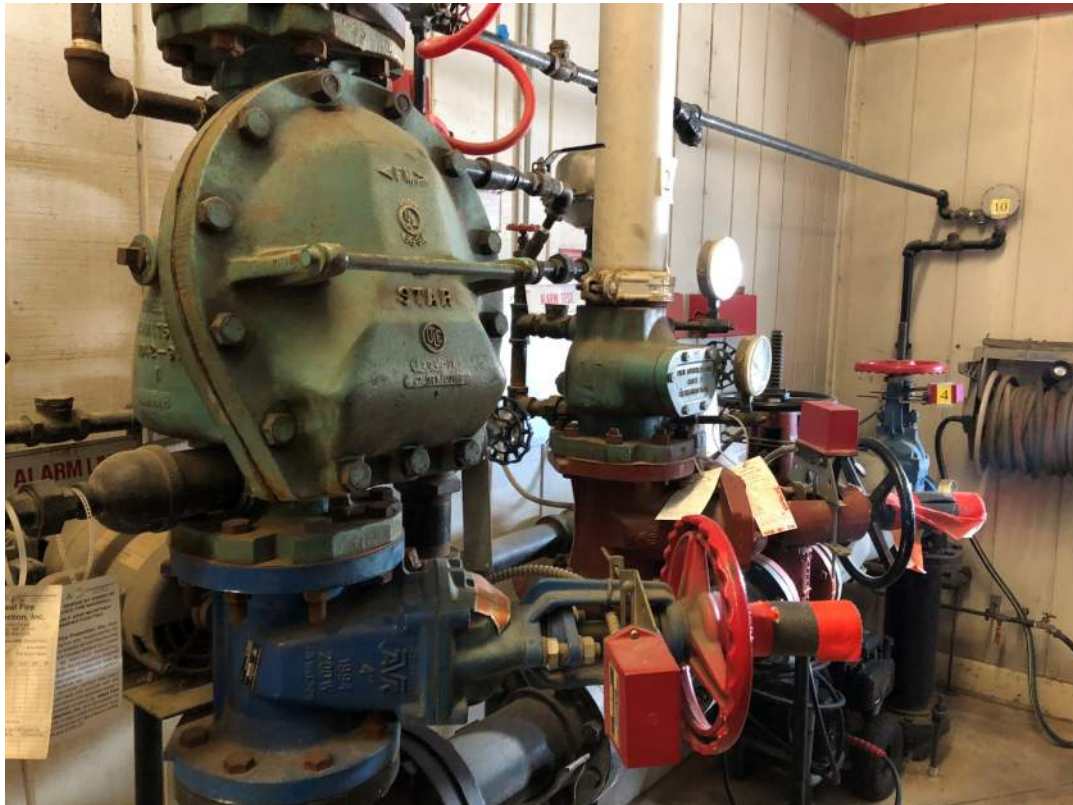
FP-1

1. The building currently has a fully automatic wet sprinkler system installed throughout the whole facility. The fire protection service enters the Apparatus Bay and piping is routed to feed all spaces in the building. This service is 8" from the site into the building and then reduced to 4" inside the building. All piping was observed to be steel with mechanical and screwed fittings. This system appears to have been installed in the 1995 renovation and is nearing the end of its useful life. (FP-1)

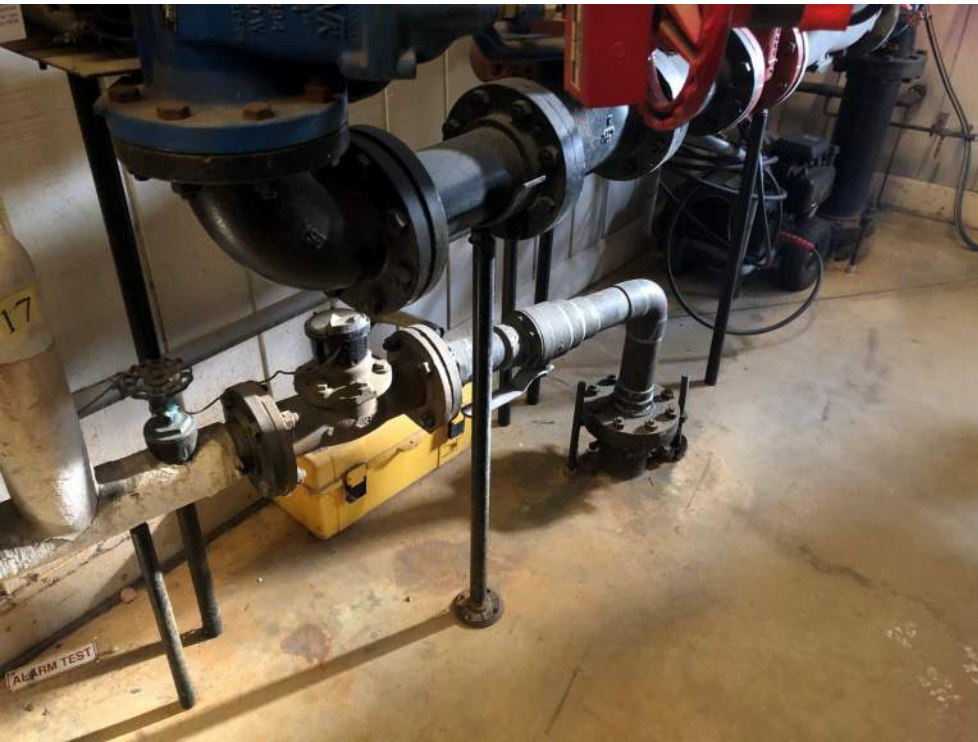
P-1

2. Domestic Water Piping: The domestic water piping in the building was observed to be copper with soldered joints. This piping appears to have been installed in the 1995 renovation and is nearing the end of their useful life.

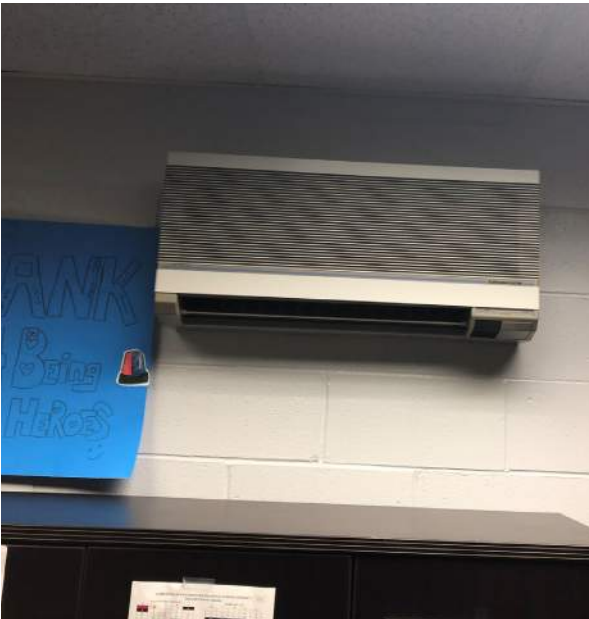
M-4

3. Air Condition in the facility was achieved through the use of Ductless Split Air Conditioners. Air conditioning was limited to Second Floor Sever Room, Booking, Dispatch, Control and Bunk Rooms. Some of these air conditions are from the 1995 renovation and are at the end of their useful life while a couple have been put in within the last few years. (M-4) All other areas that had air conditioning were from window mounted packaged Air Conditioners.

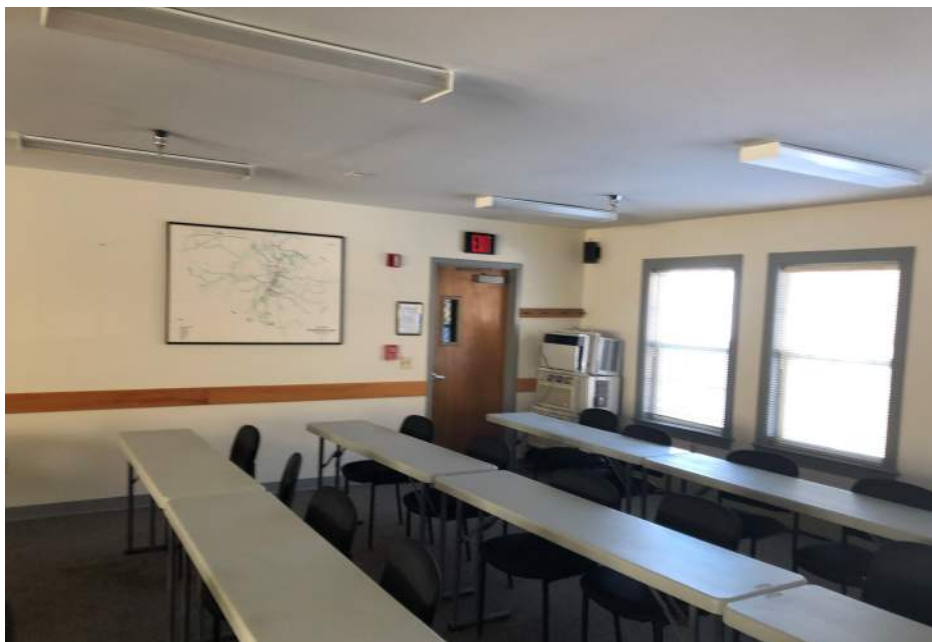
E-3

1. Lighting is accomplished by the use of 1'x4', 2'x2' and 2'x4' Fluorescent fixtures, with T8 lamps. These fixtures were installed in the 1995 renovation and are at the end of their useful life. (E-3)
2. Lighting fixtures are generally controlled by wall mounted toggle switches. No occupancy sensor and daylight control devices were observed in the building, with the exception of a few combination switch/sensors that have been added.
