**REQUEST FOR PROPOSALS (RFP)
FOR THE PURCHASE, RENOVATION &
REDEVELOPMENT OF PROPERTY OWNED BY
THE TOWN OF WESTMINSTER, MASSACHUSETTS
THE HISTORIC MEETING HOUSE**

FEASIBILITY STUDY / COST ANALYSIS RENOVATION & EXPANSION OF TOWN HALL

Town of Westminster, Massachusetts

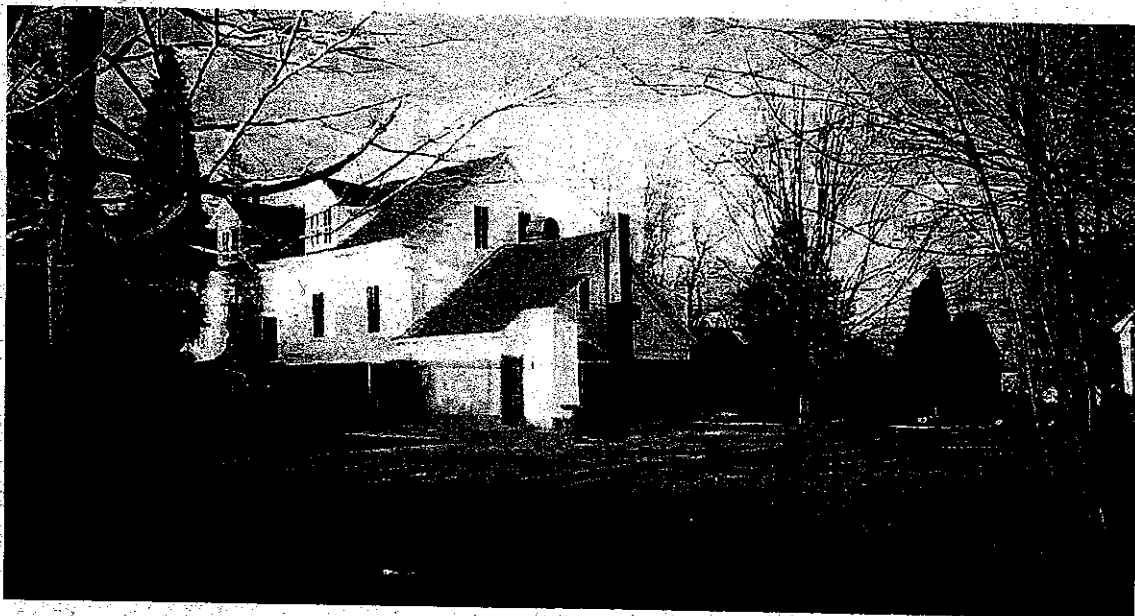
Town Hall – Rear View across Vacant Lot. Replacement of the 1 1/2 story Addition with a New Larger Addition could provide Badly Needed Space.

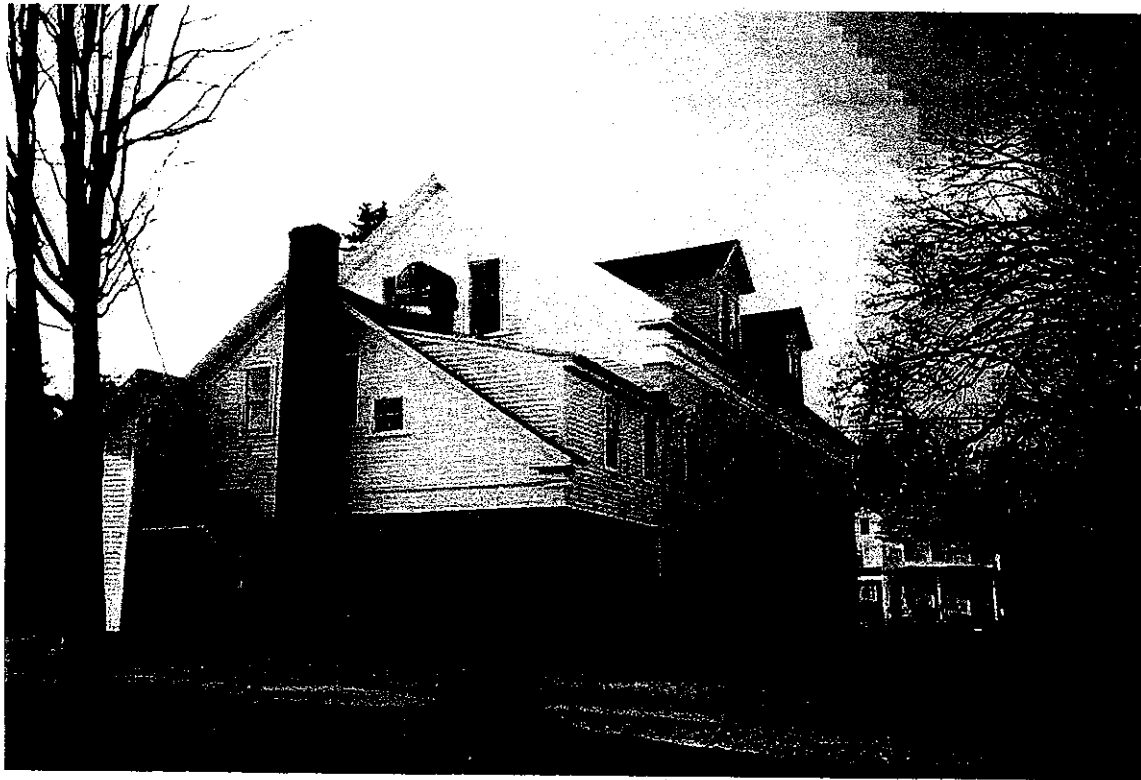
Town Hall – Rear View North. New Addition in place of 1 1/2 Story Element could include New Accessible Entrance and Elevator.

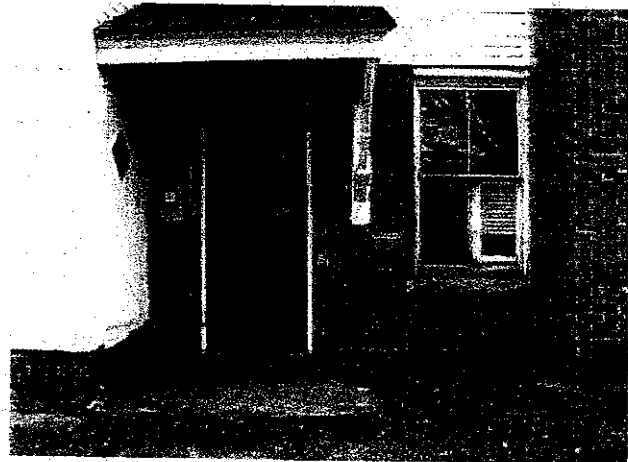
- The exterior masonry around the first floor of the structure as well as that of the chimneys is in relatively good condition, mostly needing only sporadic, spot repointing. *In addition to the spot repointing, there is an open joint at the east wall between the south extension and the earlier construction that needs to be filled with a soft, malleable high-lime mortar and weathered areas along the bases of the east and west walls and much of the south extension's west and south walls that must be repointed (item #EX-2).*
